APPENDIX B - FIELD NOTES

Field Report

Walkthrough of Danbury Branch Line Housatonic Railroad Line

September 8, 2008 to September 11, 2008

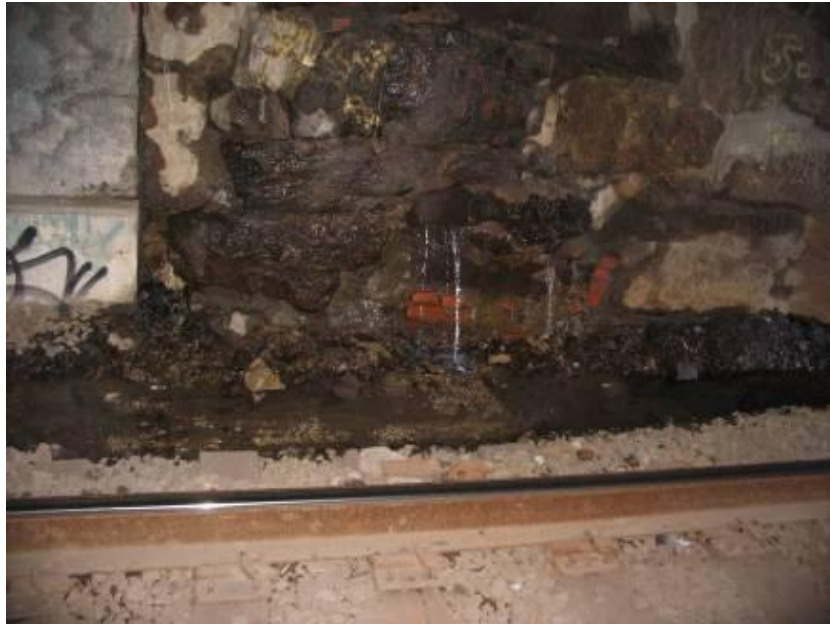
Figure 2 - Water seeping through retaining wall at south entrance of Wall St. Tunnel (MNR MP 1.5)

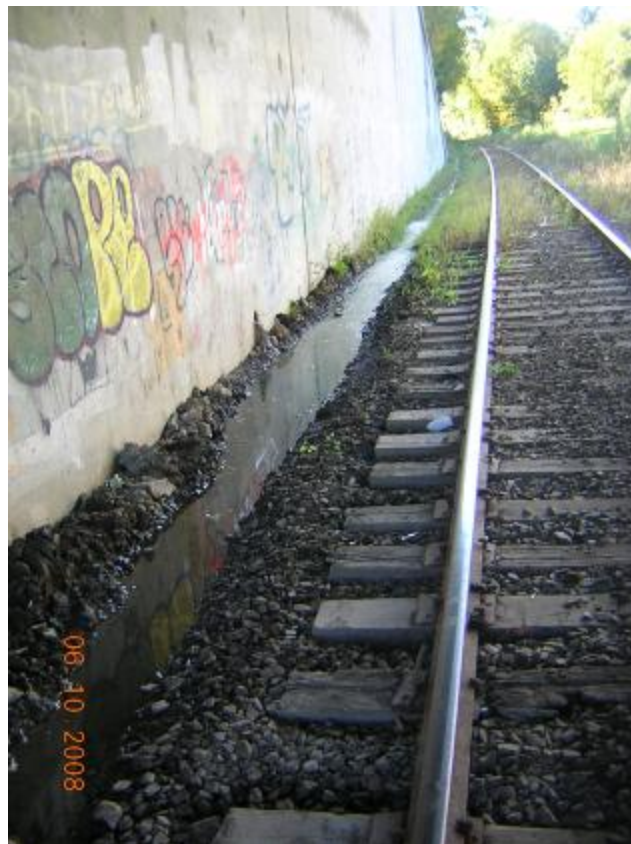
Figure 3 - Standing water by tracks under Whisconier Rd Bridge (HRR – Berkshire Line MP 4.4)

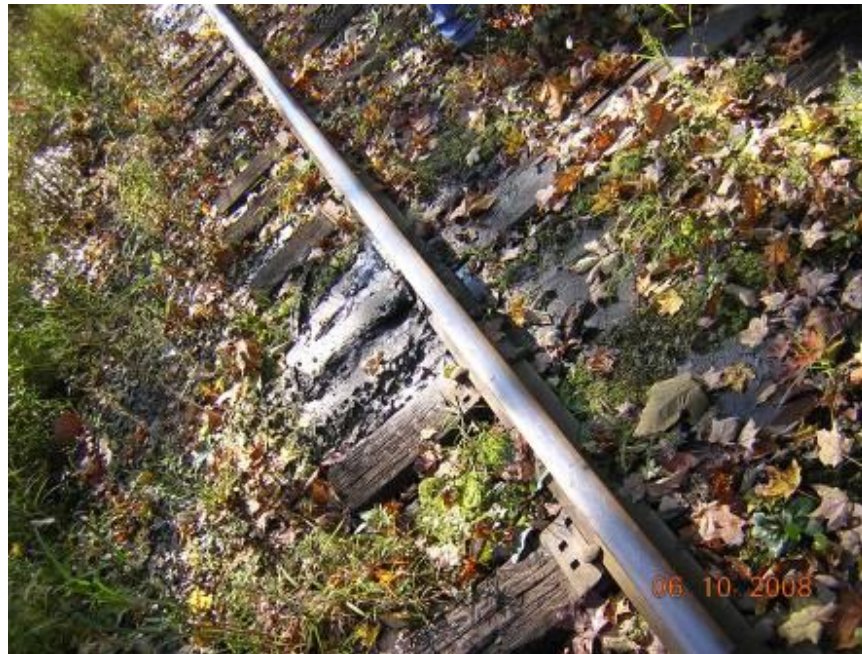
Figure 4 - Poor drainage on tracks HRR - Berkshire Line MP 3.1)

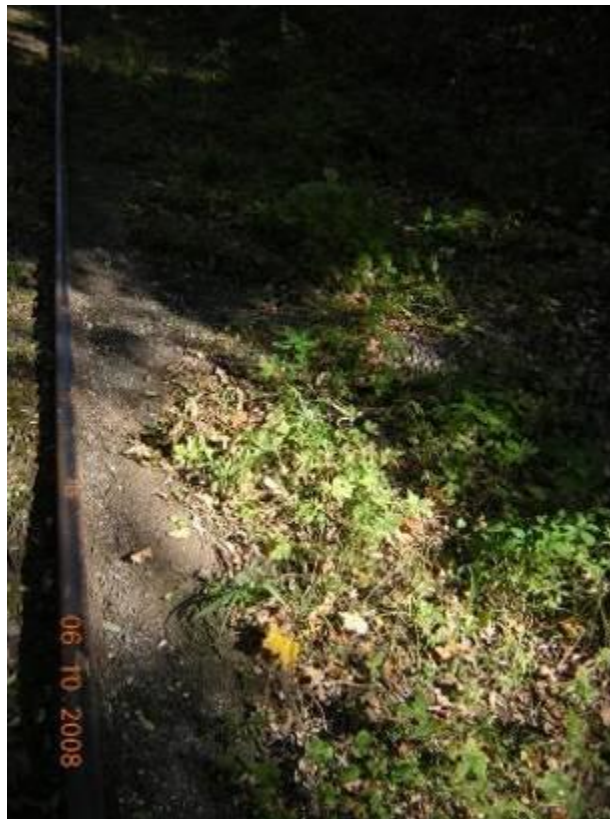
Figure 5 - Sediments washed down to tracks to TOR (HRR - Berkshire Line MP 1.5)

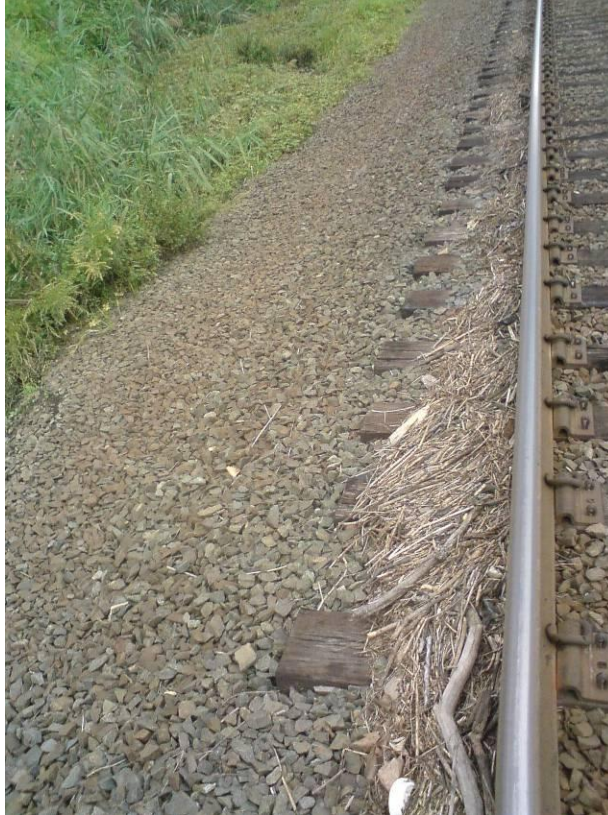
important consideration is between Bethel Station and Great Pasture Rd, where it was observed that the tracks had recently been flooded and debris from flooding remained along the tracks.

Figure 6 - Debris on tracks due to flooding (MNR MP 21.3)

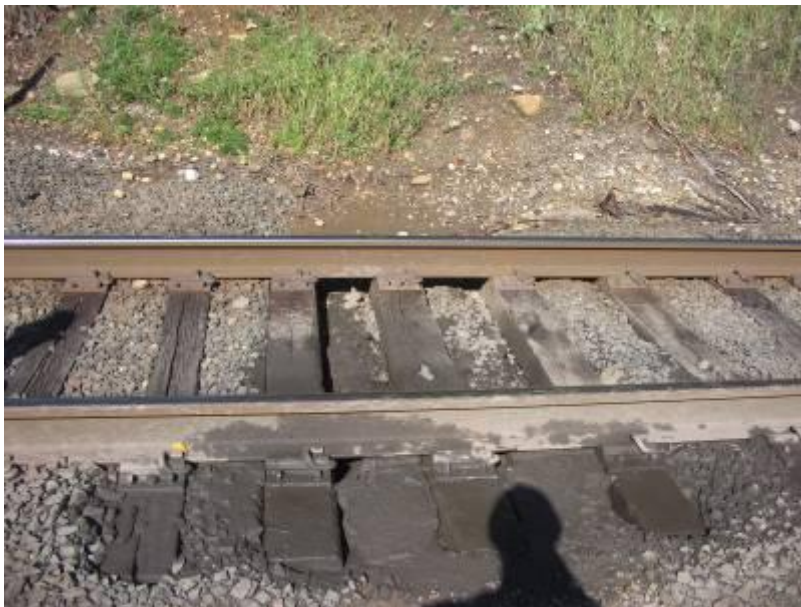
Figure 7 - Poor maintenance of grade and ballast (MNR MP 9.40)

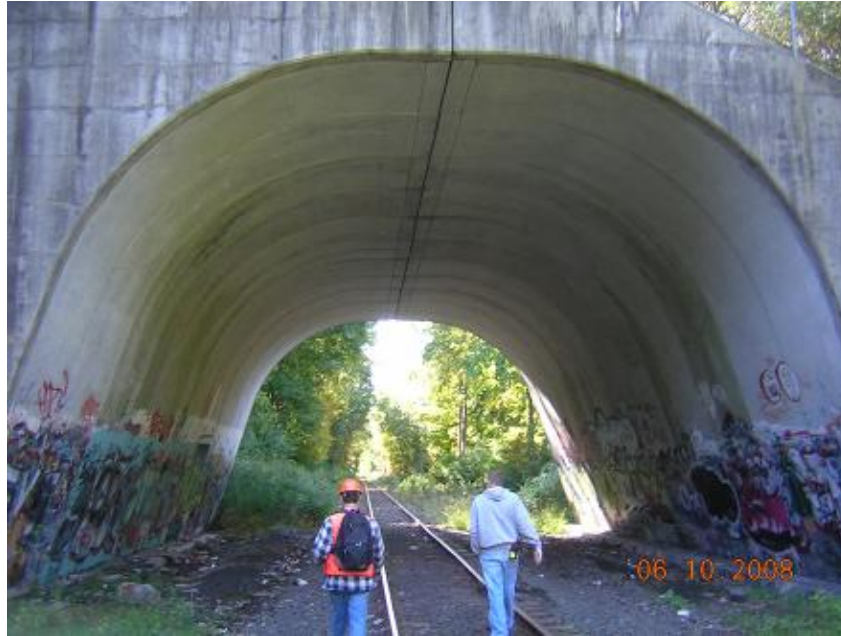
Figure 8 - Gray's Bridge Rd (HRR – Berkshire Line MP 1.59)
Overhead bridge is in good condition.

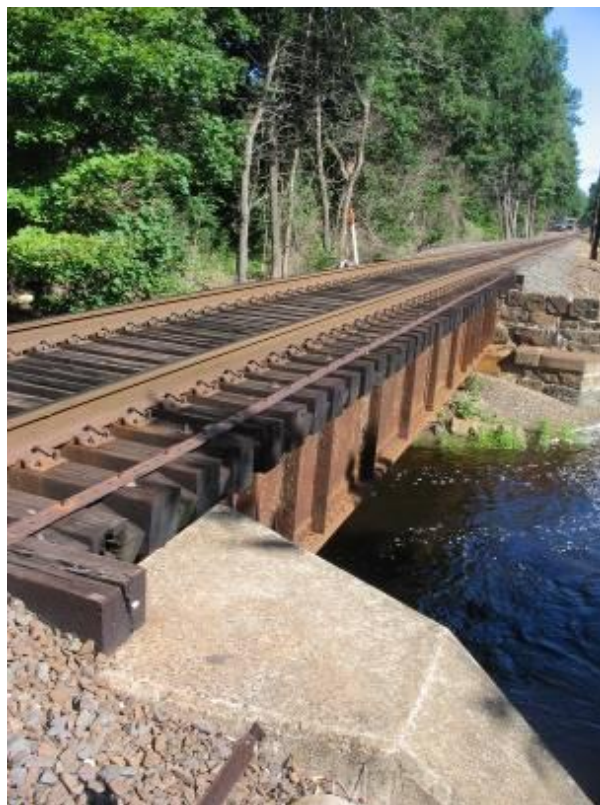
Figure 9 - Norwalk River (MNR MP 8.7)

Bridge is in poor condition according to bridge inspection reports. Observed deficiencies include rust on steel beam supports.

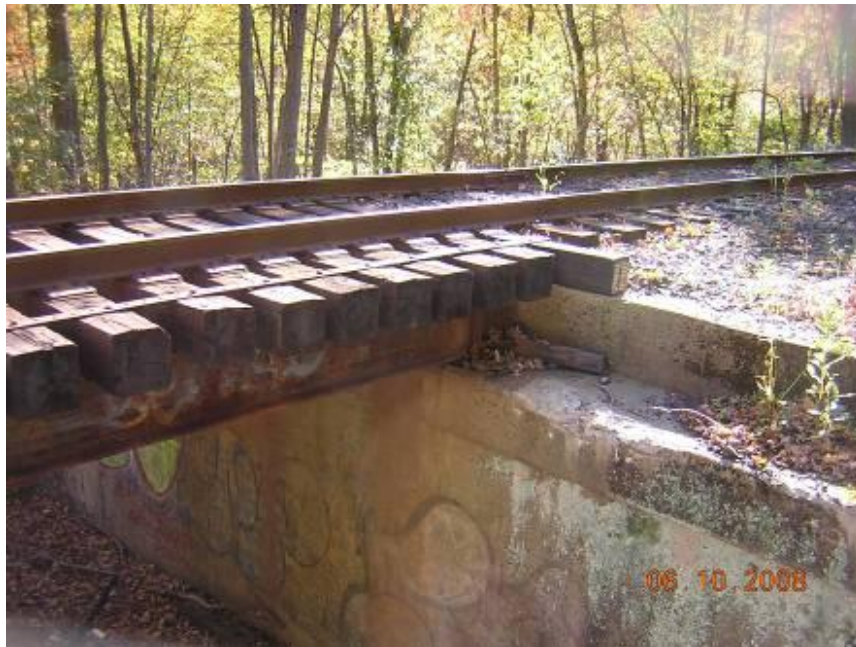
Figure 10 - Cattle Pass (HRR – Berkshire Line MP 2.96)
Concrete spalling observed on abutment wall.

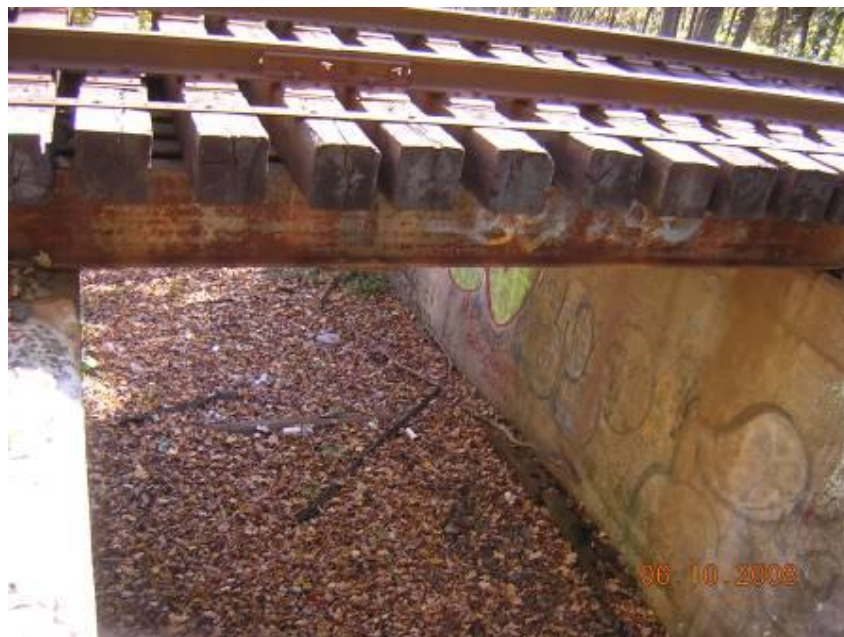
Figure 11 - Cattle Pass (HRR – Berkshire Line MP 2.96)
Steel support beam rusted and in need of painting.

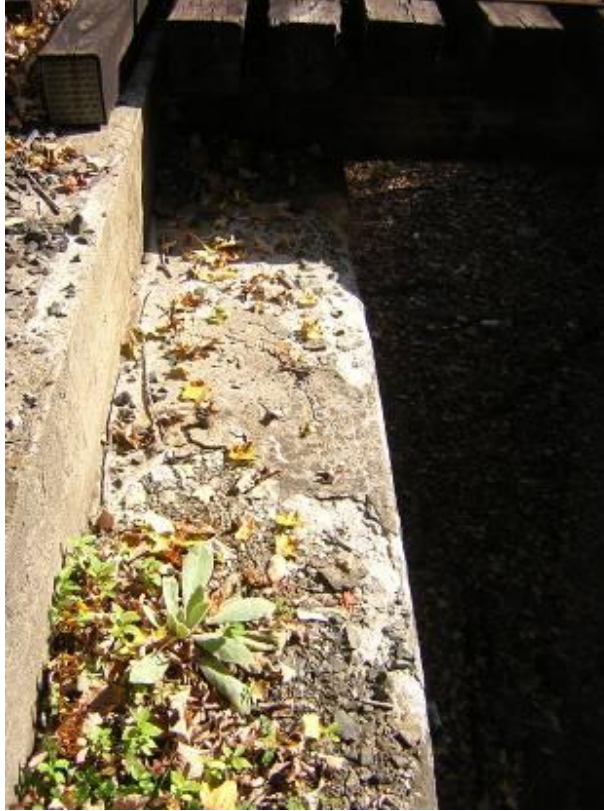
Figure 12 - Cattle Pass (HRR – Berkshire Line MP 2.96)

Observations include concrete spalling on abutment wall and vegetation growth.

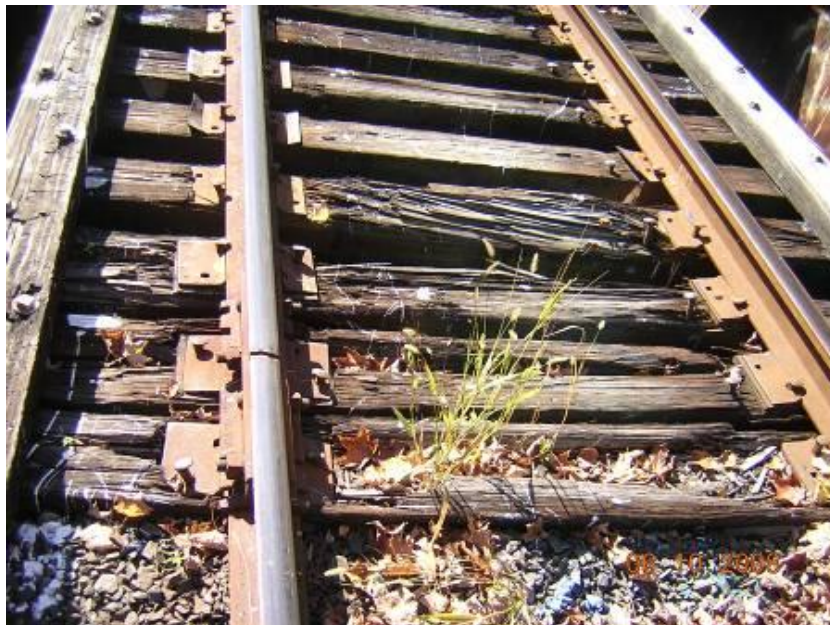
Figure 13 - Junction Rd (HRR – Berkshire Line MP 2.51)

Deteriorating timber cross ties were observed on bridge.

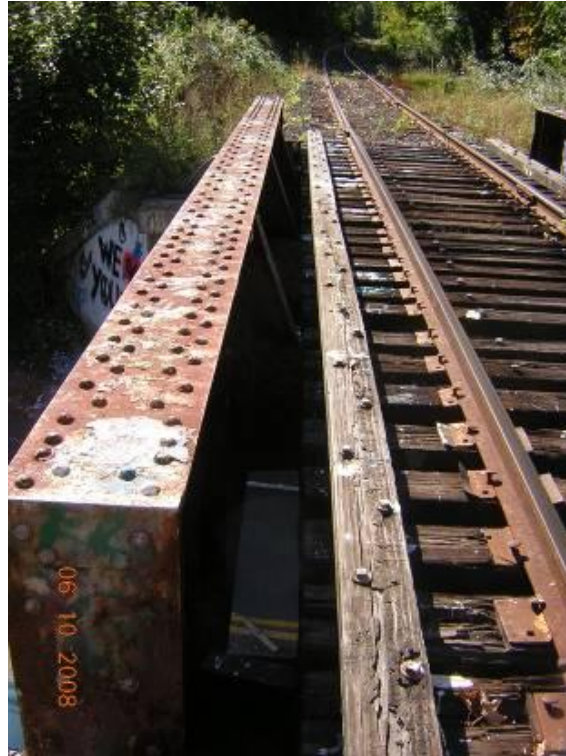
Figure 14 - Junction Rd (HRR – Berkshire Line MP 2.51)
Deteriorating timber and rusting at truss were observed.

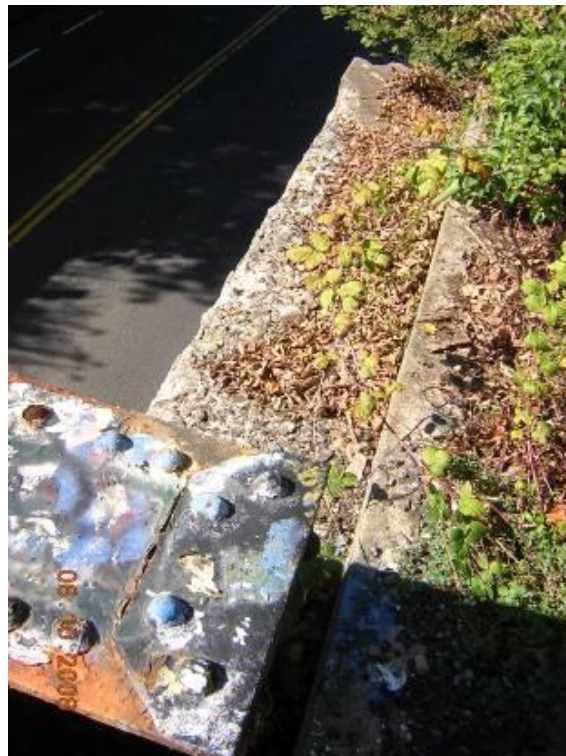
Figure 15 - Junction Rd (HRR – Berkshire Line MP 2.51)
Observations include rusting at truss, spalling along concrete abutment wall.

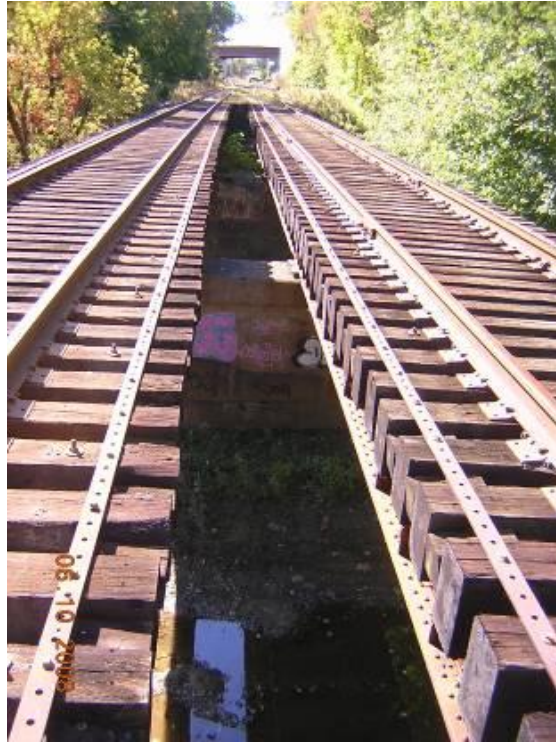
Figure 16 Still River (HRR - TILCON/Maybrook Line MP 79.65)

Moderate corrosion on girders. Bearing shim at north side, span #2 at pier is fully out of position. Severe corrosion on top lateral bracings at various locations. Anchor bolts in need of repair.

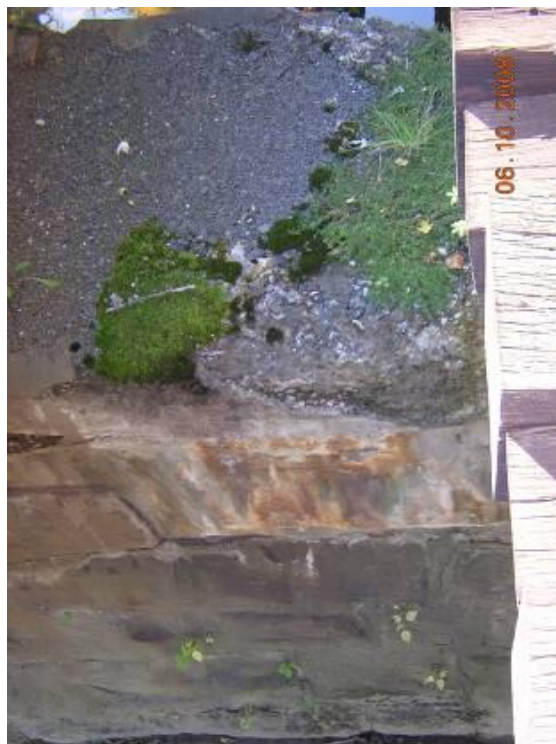
Figure 17 - Still River (HRR - TILCON/Maybrook Line MP 79.65)

Stone abutment wall in poor condition.

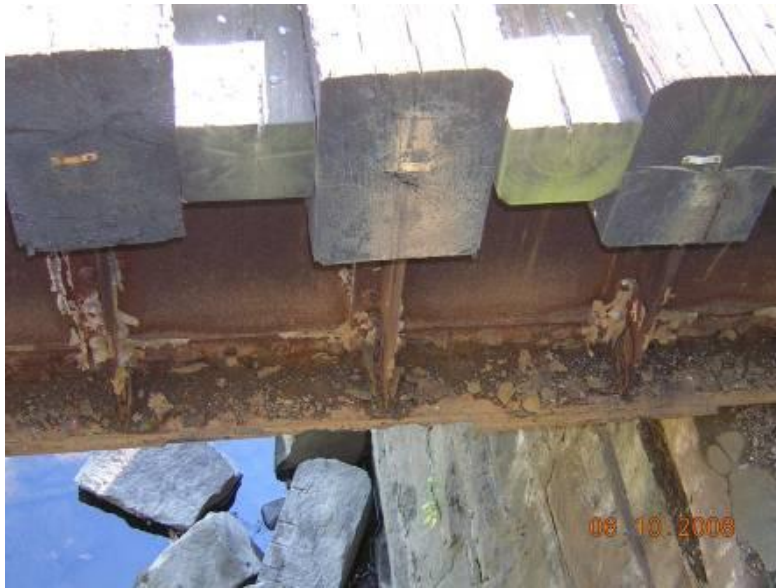
Figure 18 - MP 79.65 UG Still River (TILCON/Maybrook)

Stones dislodging and falling out of base at north bearing at east abutment were observed.
Bottom flange is severely corroded.

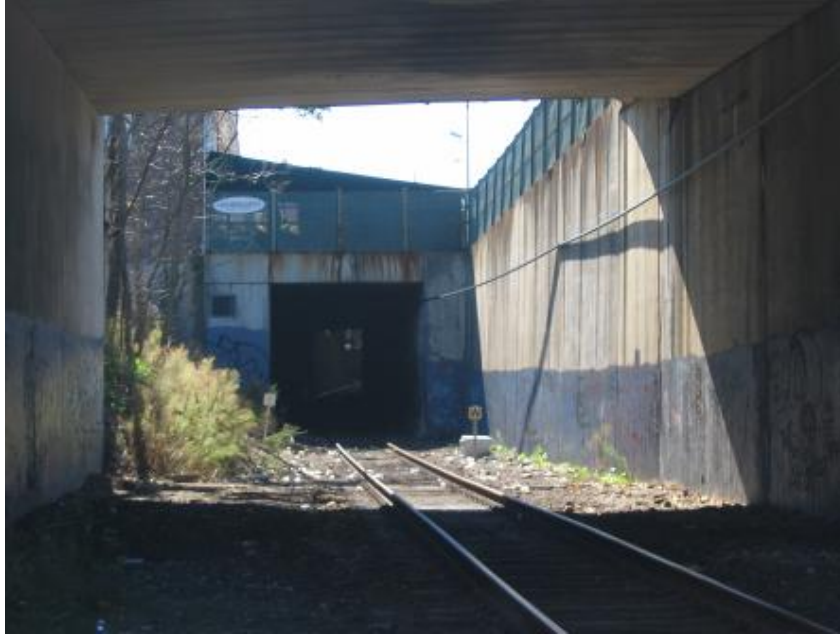
Figure 19 – North entrance of Wall Street Tunnel (MNR MP 1.5)
Restrictive horizontal clearance at South Norwalk tunnel.
